**DEPARTMENT OF TRANSPORTATION****DIVISION OF ENGINEERING SERVICES**

Quality Assurance and Source Inspection

Contract #: 04-0120F4Cty: SF/ALA Rte: 80 PM: 13.2/13.9File #: 1.28**WELDING INSPECTION REPORT****Resident Engineer:**Pursell, Gary**Address:** 333 Burma Road**City:** Oakland, CA 94607**Report No:** WIR-000560**Date Inspected:** 28-Sep-2007**Project Name:** SAS Superstructure**OSM Arrival Time:** 700**Prime Contractor:** American Bridge/Fluor Enterprises, a JV**OSM Departure Time:** 1530**Contractor:** American Bridge/Fluor Enterprises, a JV**Location:** Benicia, CA**CWI Name:** Michael Johnson**CWI Present:** Yes No**Inspected CWI report:** Yes No N/A**Rod Oven in Use:** Yes No N/A**Electrode to specification:** Yes No N/A**Weld Procedures Followed:** Yes No N/A**Qualified Welders:** Yes No N/A**Verified Joint Fit-up:** Yes No N/A**Approved Drawings:** Yes No N/A**Approved WPS:** Yes No N/A**Delayed / Cancelled:** Yes No N/A**Bridge No:** 34-0006**Component:** Procedure Qualification Record (PQR) Test**Summary of Items Observed:**

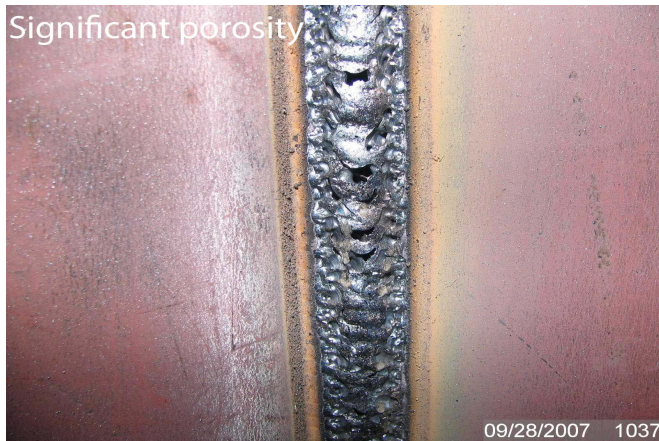
Following the replacement of the wire feeder unit, the QA Inspector observed the welders place a second set of PQR test plates in the 3G position. The QA Inspector was informed that this set of test plates will have designation ABF-PQR-020-1-CR.

Welder Dan Gordon deposited (3) sequential weld passes utilizing a Bug-O Systems mechanical device that travels on a magnetic track. Mr. Johnson and the QA Inspector monitored welding amperage, voltage and travel

speed parameters. The welders are the same welding wire and gas as mentioned above. For specific welding parameters recorded during this PQR see Caltrans Welding Witness Report, TL-6032 generated upon completion of this PQR test plate.
